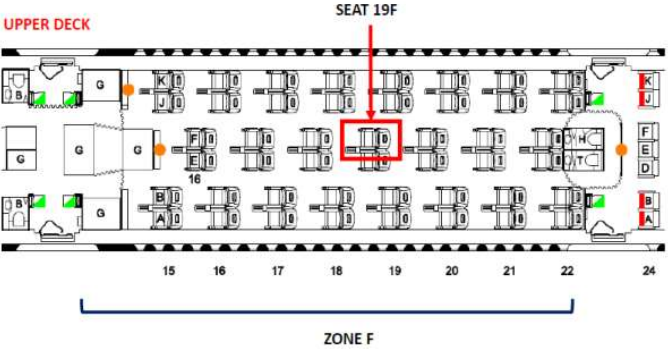
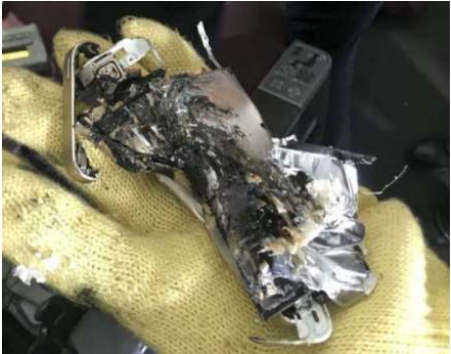
During the flight from Sydney to Dallas/Fort Worth the smoke was registered in the passenger cabin. The smoke was coming from seat 19F on the upper deck of A380. The crew found a **crushed personal electronic device (PED)** wedged tightly in the seat mechanism. The cabin crew assessed that the crushed PED contained a lithium battery. By that time, the PED was no longer emitting smoke, however a strong acrid smell remained in the cabin. The cabin crew took appropriate emergency procedures, no passengers were injured and aircraft was not damaged in the incident.

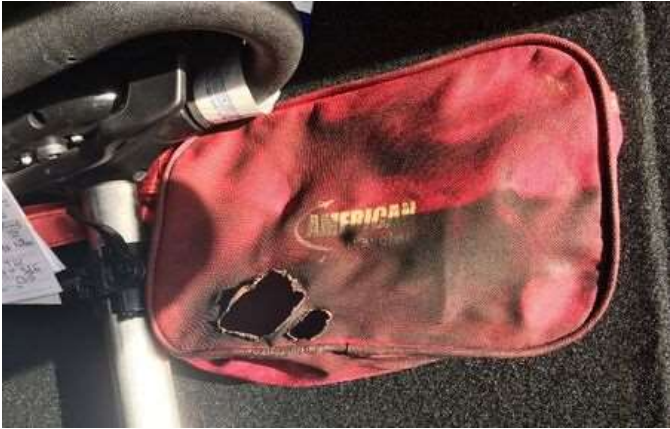
On 27th October 2019, an under-floor hold fire warning was annunciated in the flight deck of a Boeing 737-900 which had been pushed back at Paris CDG and was about to begin taxiing. Since there were no signs of fire in the passenger cabin or during an emergency services external inspection, a non-emergency disembarkation of all occupants was made. The hold concerned was then opened and fire damage sourced to the **overheated lithium battery in a passenger wheelchair** was discovered. The investigation identified a number of weaknesses in both the applicable handling and loading procedures and compliance with the ones in place.

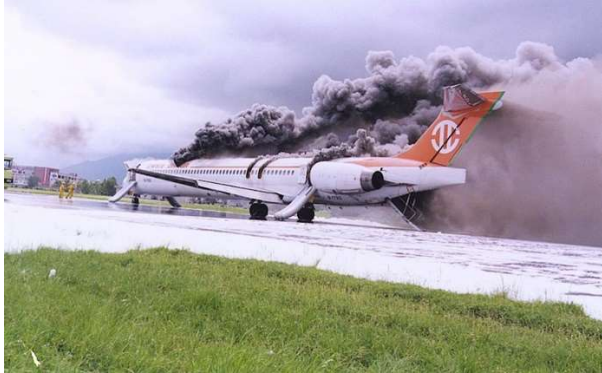
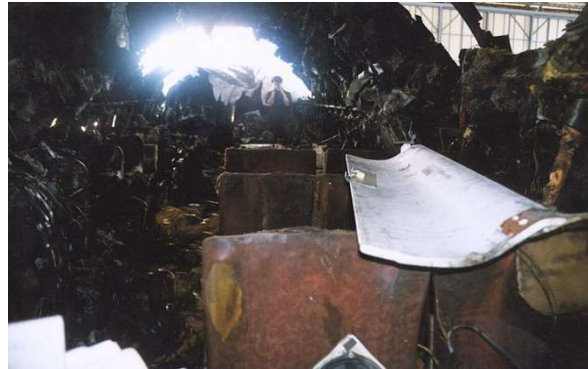
On 24th August 1999 MD-90 departed from Taipei Songshan Airport (TSA) bound for Hualien Airport (HUN). It was carrying 90 passengers and six crew. Shortly after landing, an explosion was heard in the front section of the passenger cabin and thick black smoke poured from one of the overhead luggage compartments on the right hand side of the plane. Insulation and charred luggage littered the runway. Passengers were swiftly evacuated, but it took firefighters more than half an hour to control

the fire. Twenty-eight people were injured, one of them died. Aircraft was damaged beyond repair. Investigation identified that the blast was caused by **two household bleach plastic bottles filled by gasoline**. The gasoline leaked during the flight, formed combustible vapour in the stowage bin and exploded when impact of the landing caused **short-circuit in a motorbike battery** in a nearby overhead luggage compartment.
